NASA Technical Memorandum 86347

**DIRECT-STRIKE LIGHTNING PHOTOGRAPHS,
SWEPT-FLASH ATTACHMENT PATTERNS,
AND FLIGHT CONDITIONS FOR
STORM HAZARDS '82**

**Klaus P. Zaepfel,
Bruce D. Fisher,
and Merle S. Ott**

February 1985

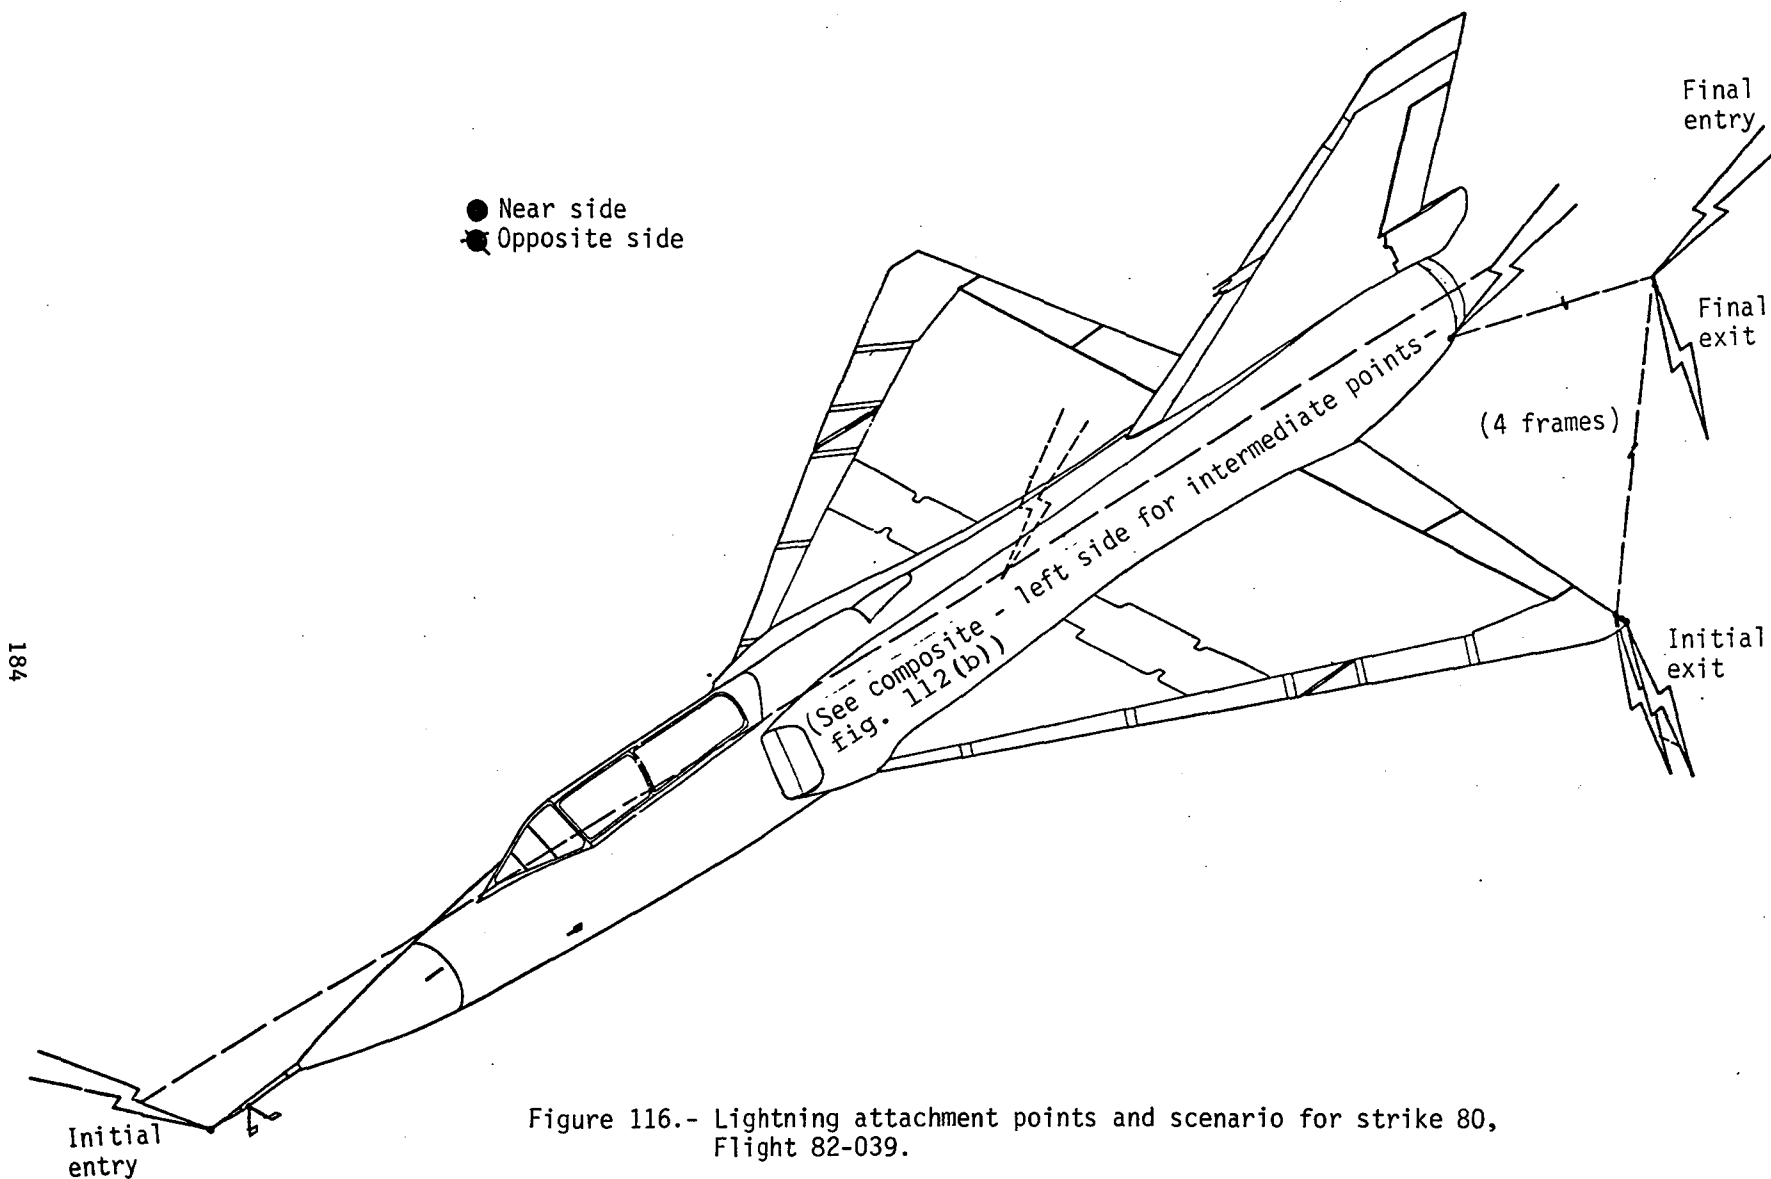
Figure 116.- Lightning attachment points and scenario for strike 80,
Flight 82-039.

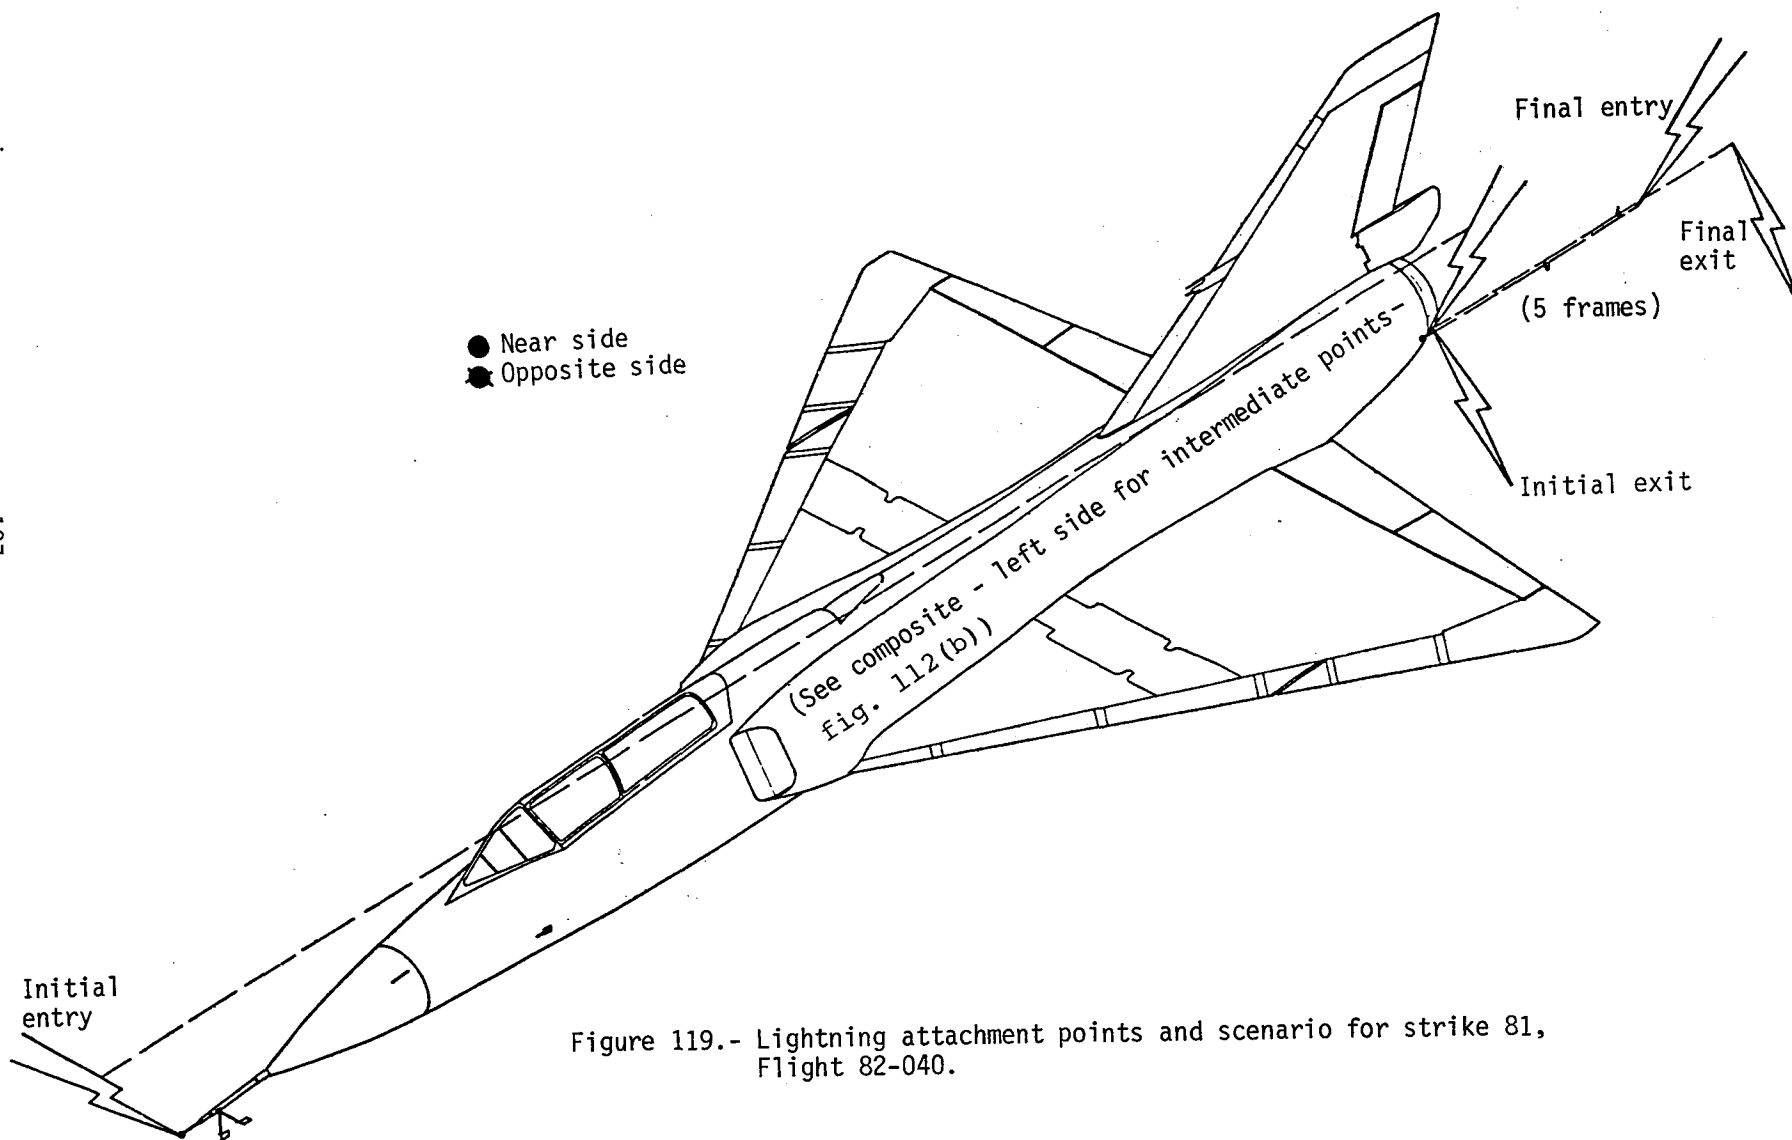
Figure 119.- Lightning attachment points and scenario for strike 81, Flight 82-040.

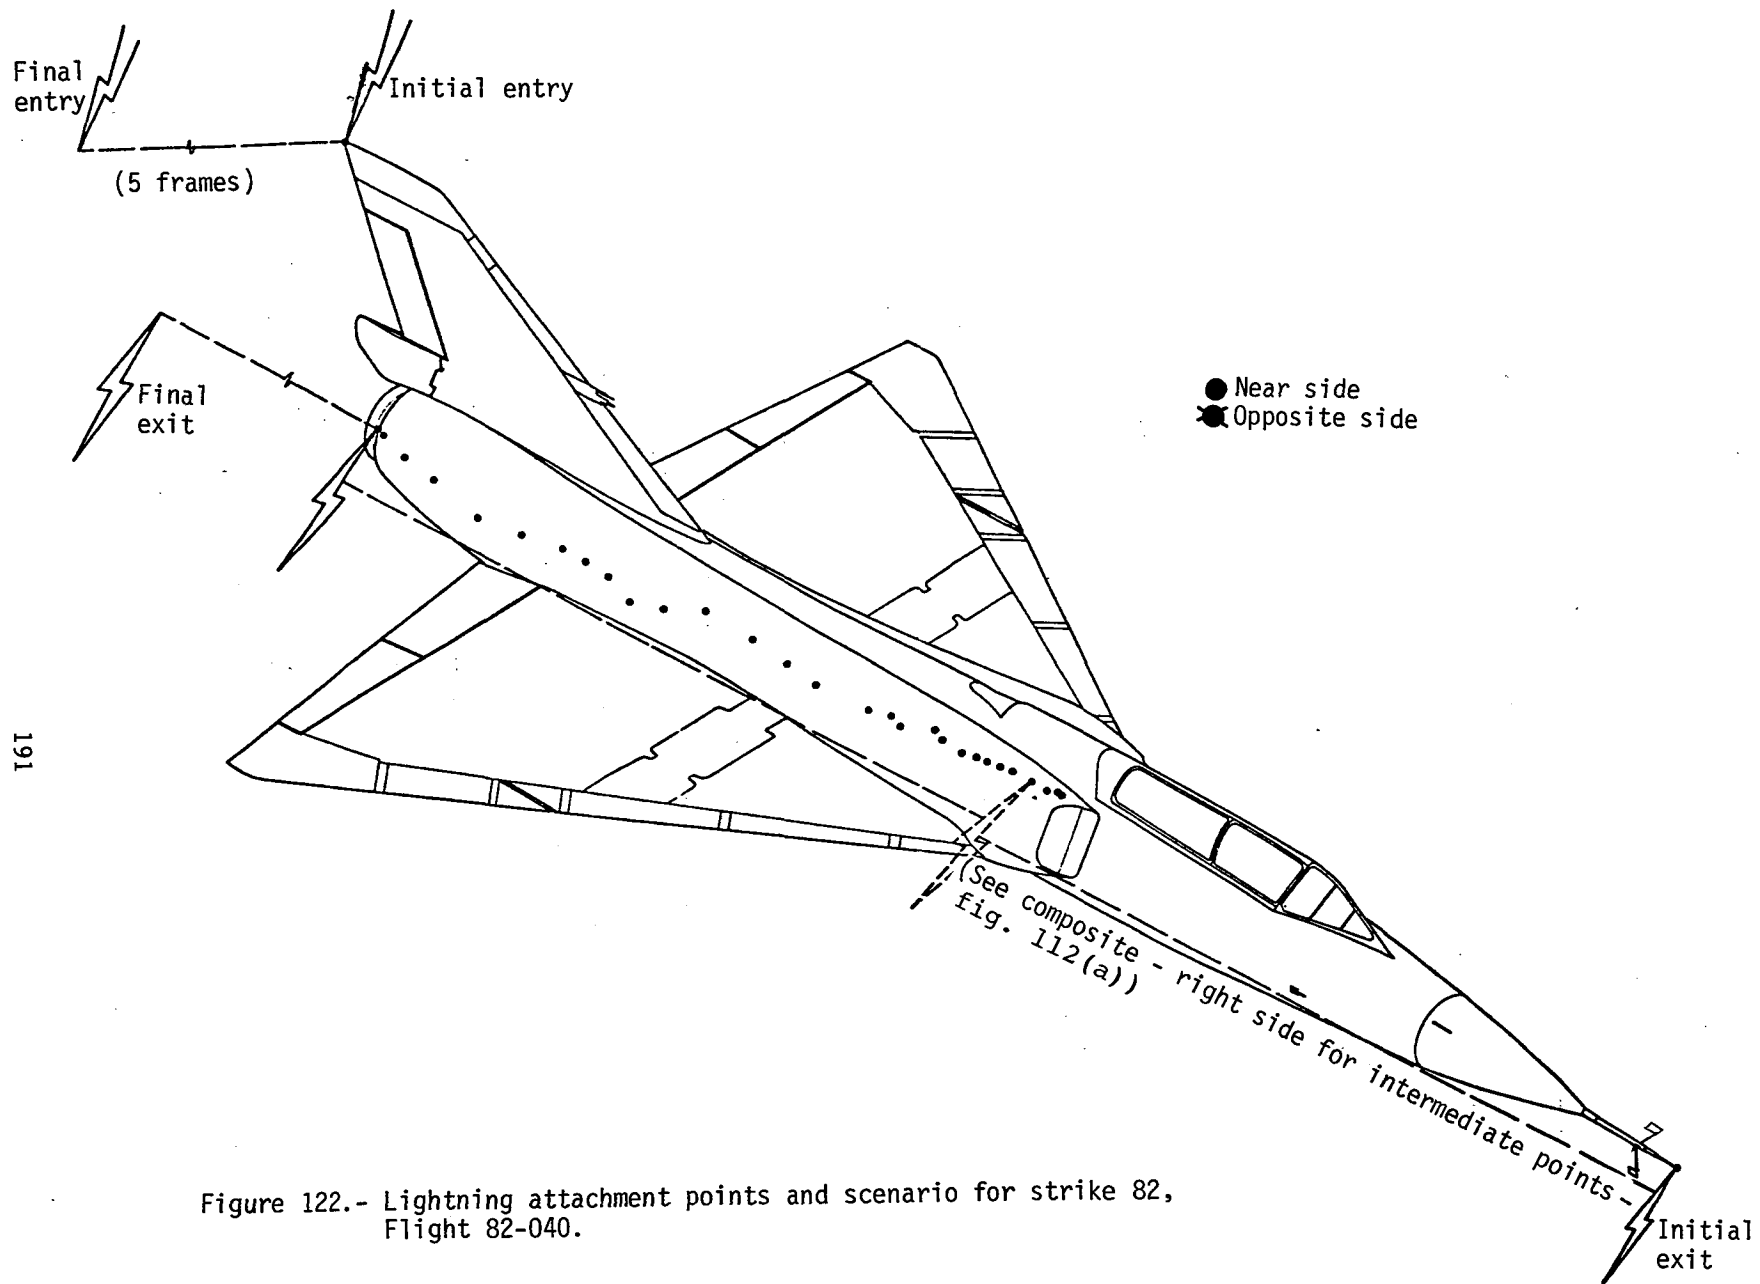
Figure 122.- Lightning attachment points and scenario for strike 82, Flight 82-040.

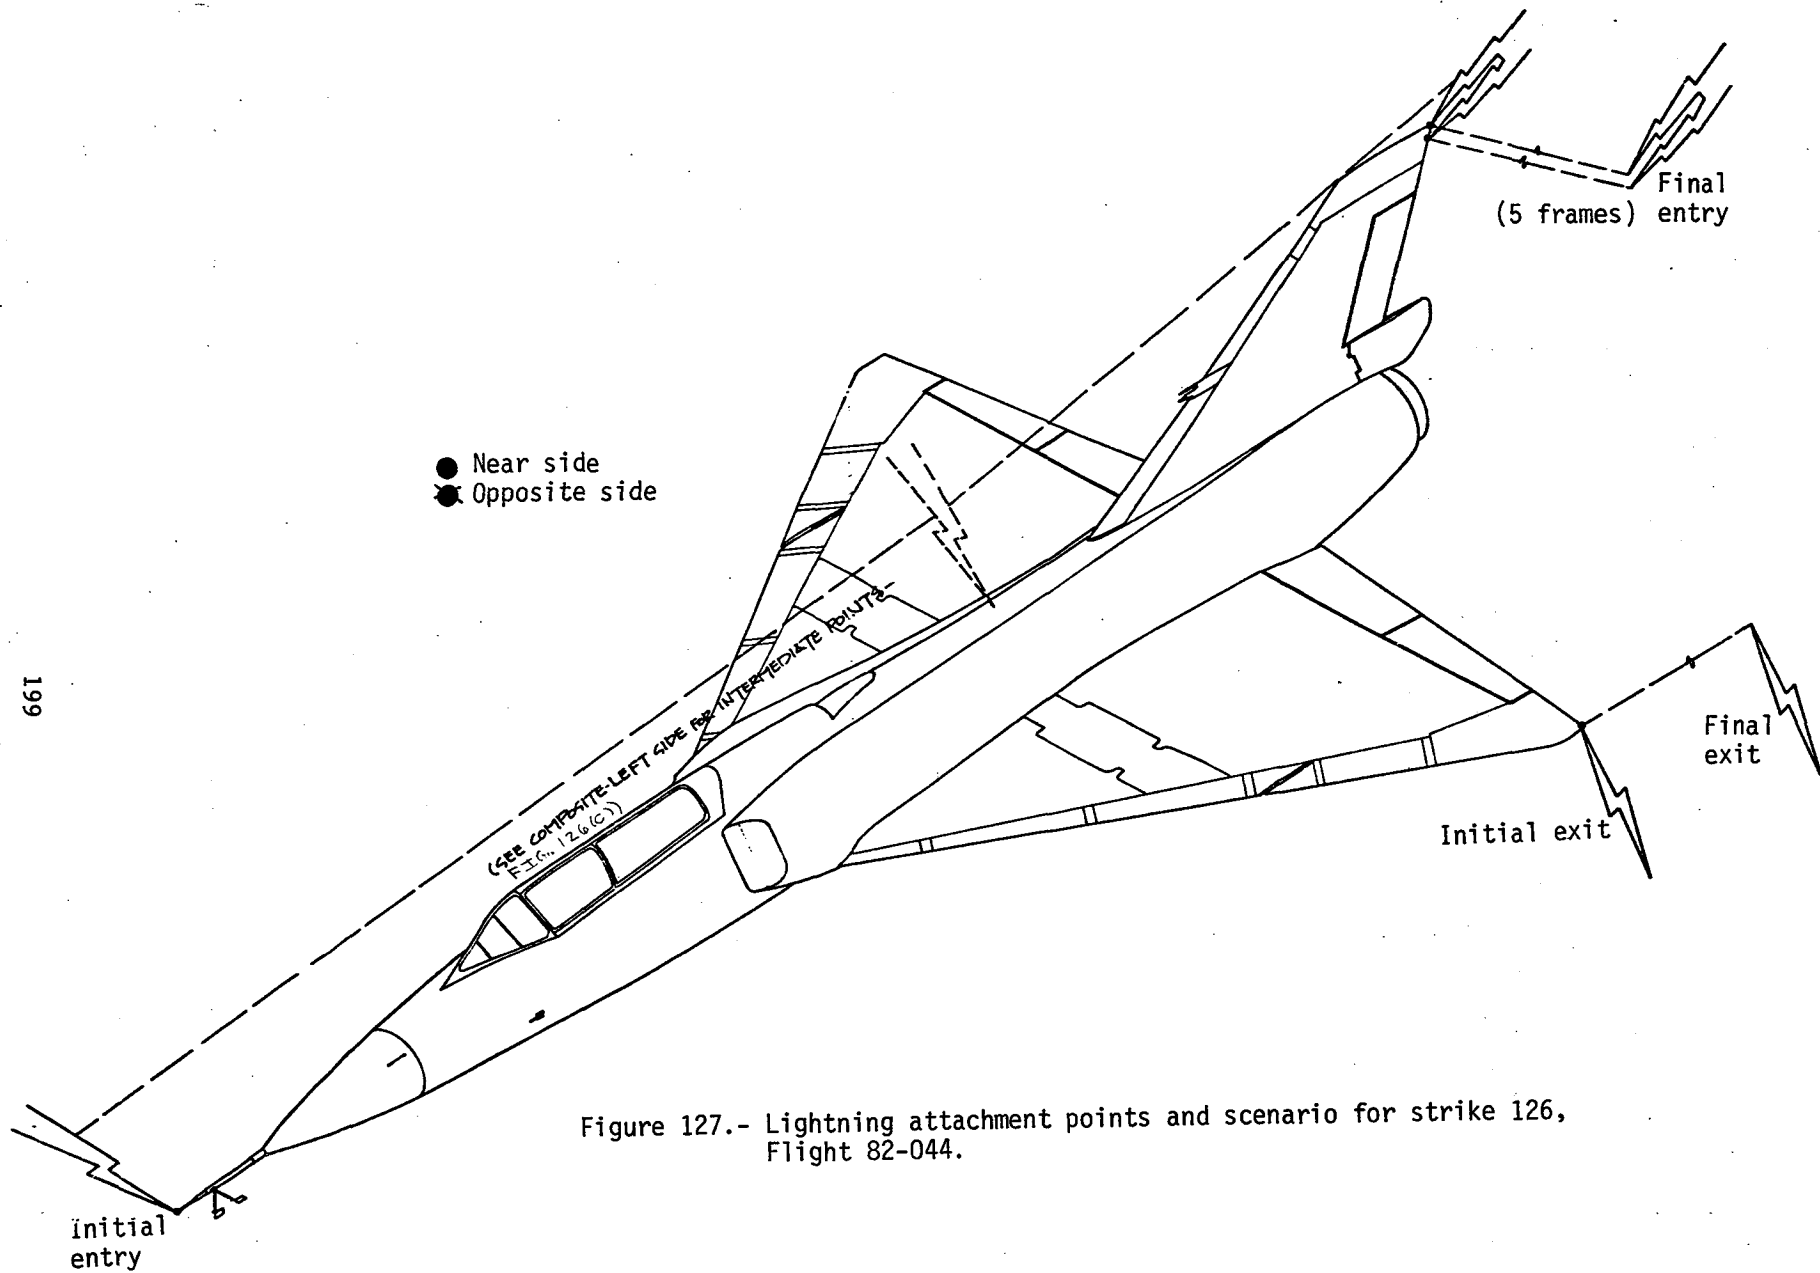
Figure 127.- Lightning attachment points and scenario for strike 126, Flight 82-044.

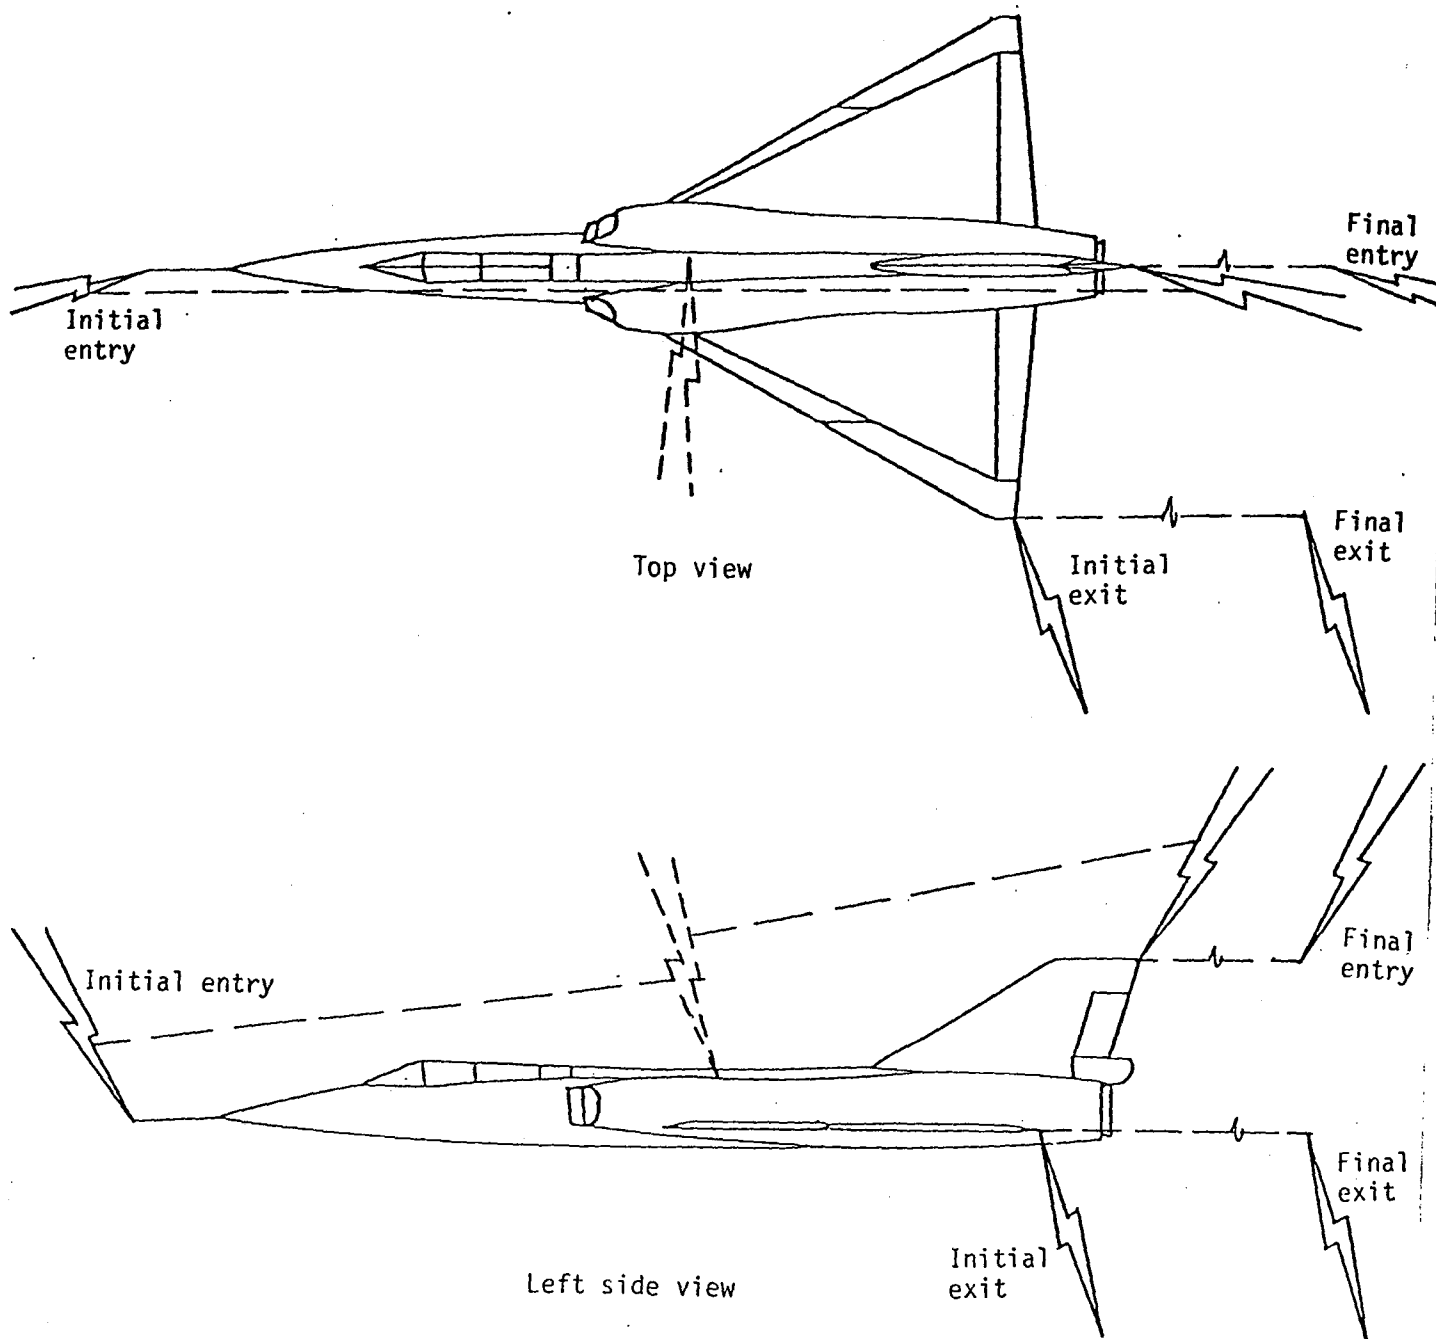
Figure 128.- Lightning attachment point scenario for strike 126, Flight 82-044.

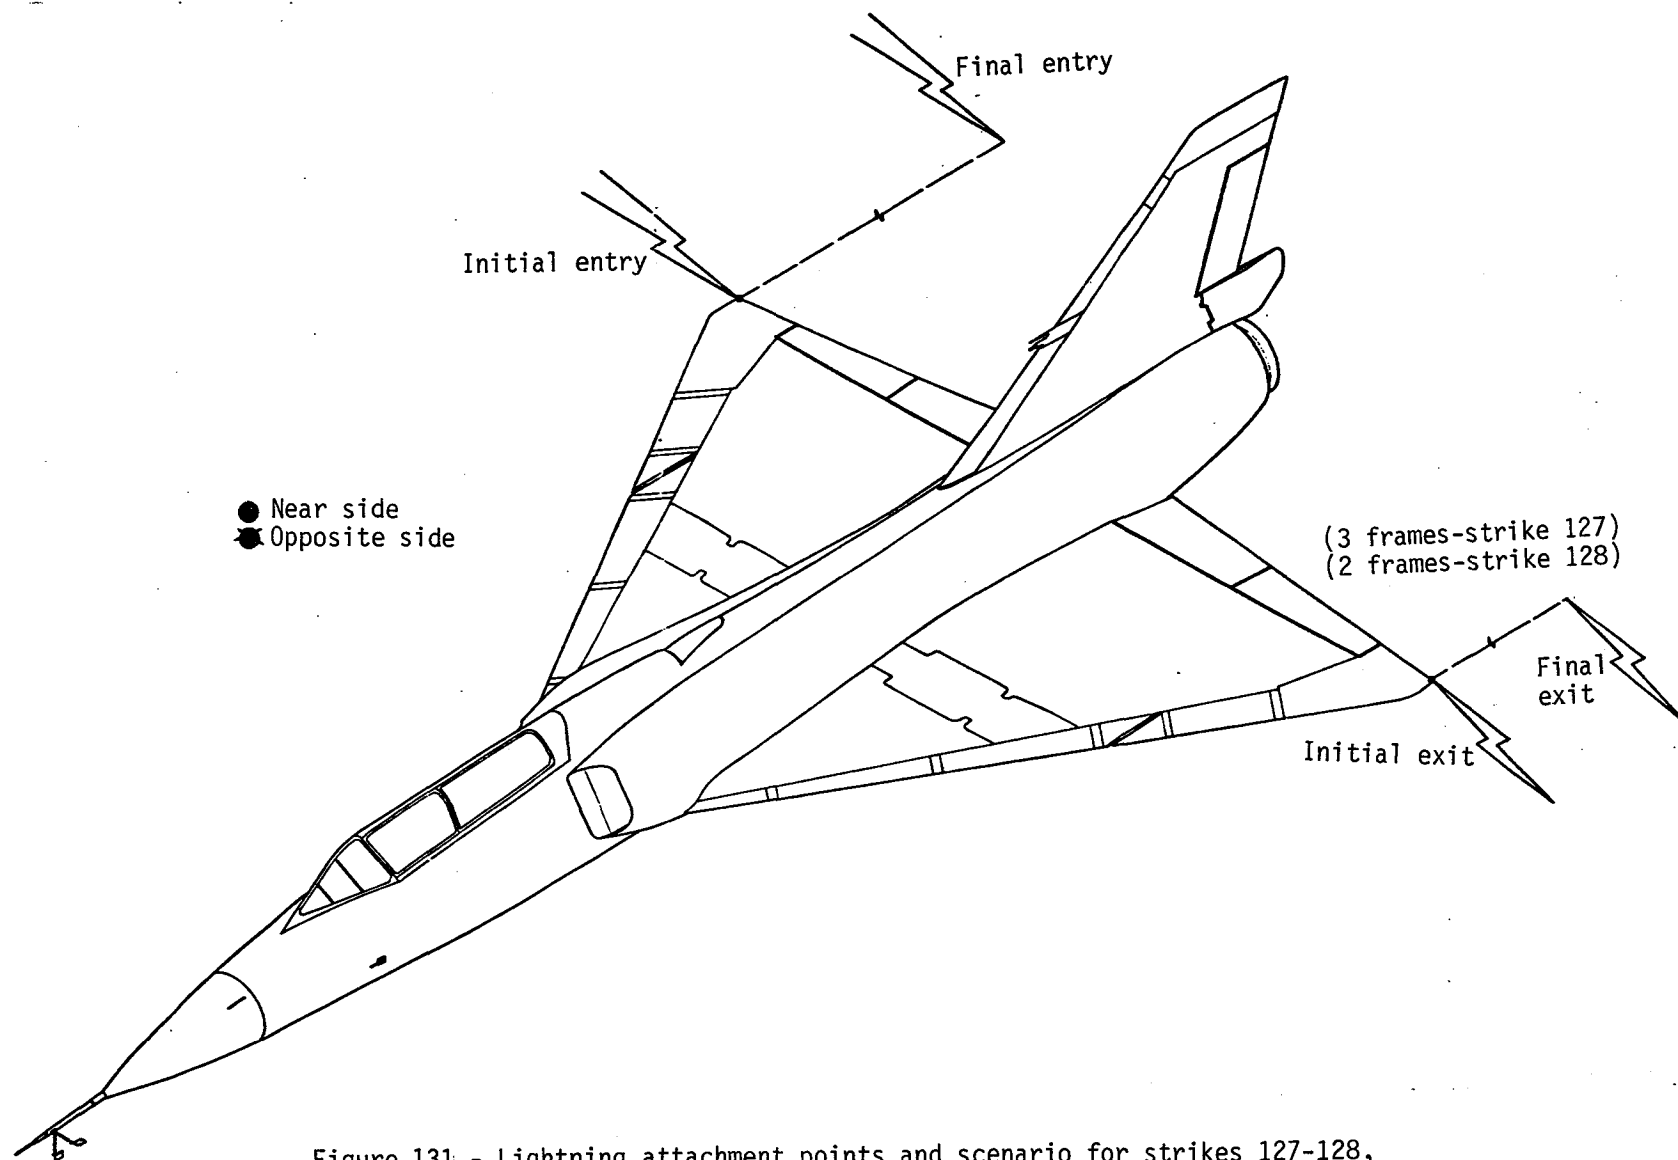
Figure 131.- Lightning attachment points and scenario for strikes 127-128, Flight 82-044.

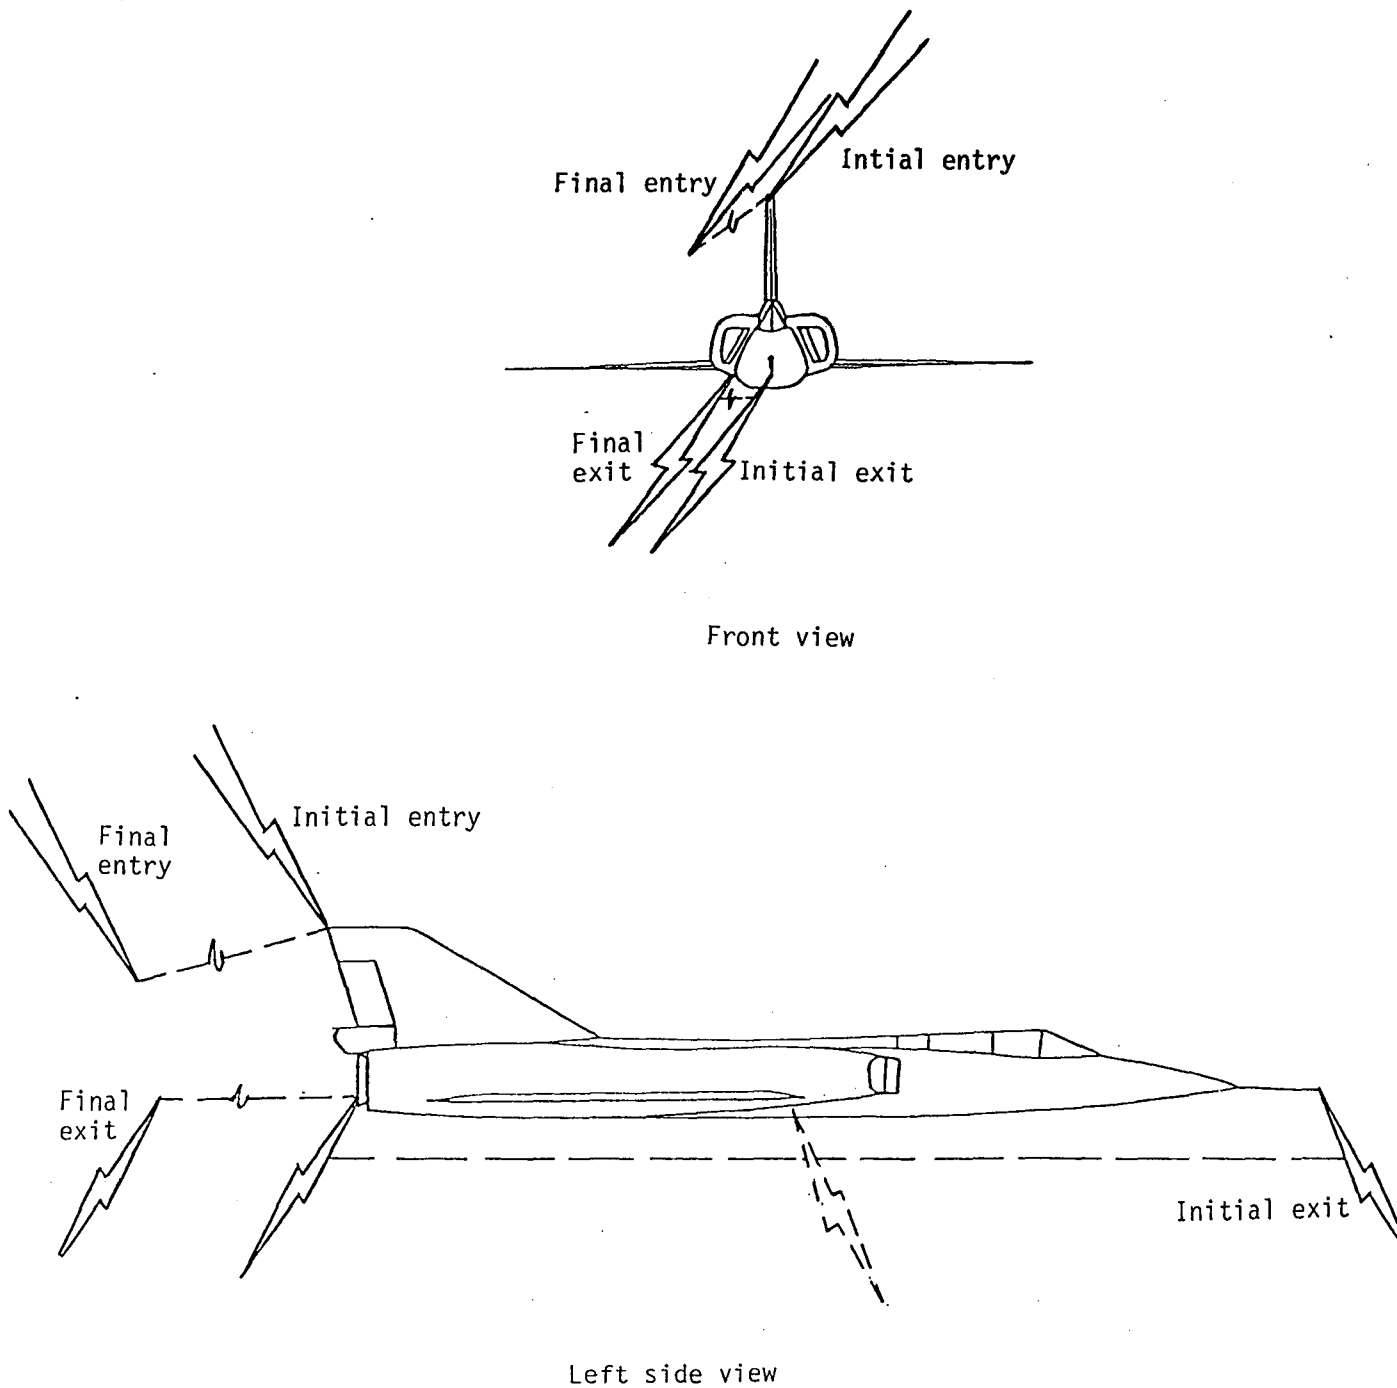
Figure 138.- Lightning attachment point scenario for strike 131, Flight 82-044.

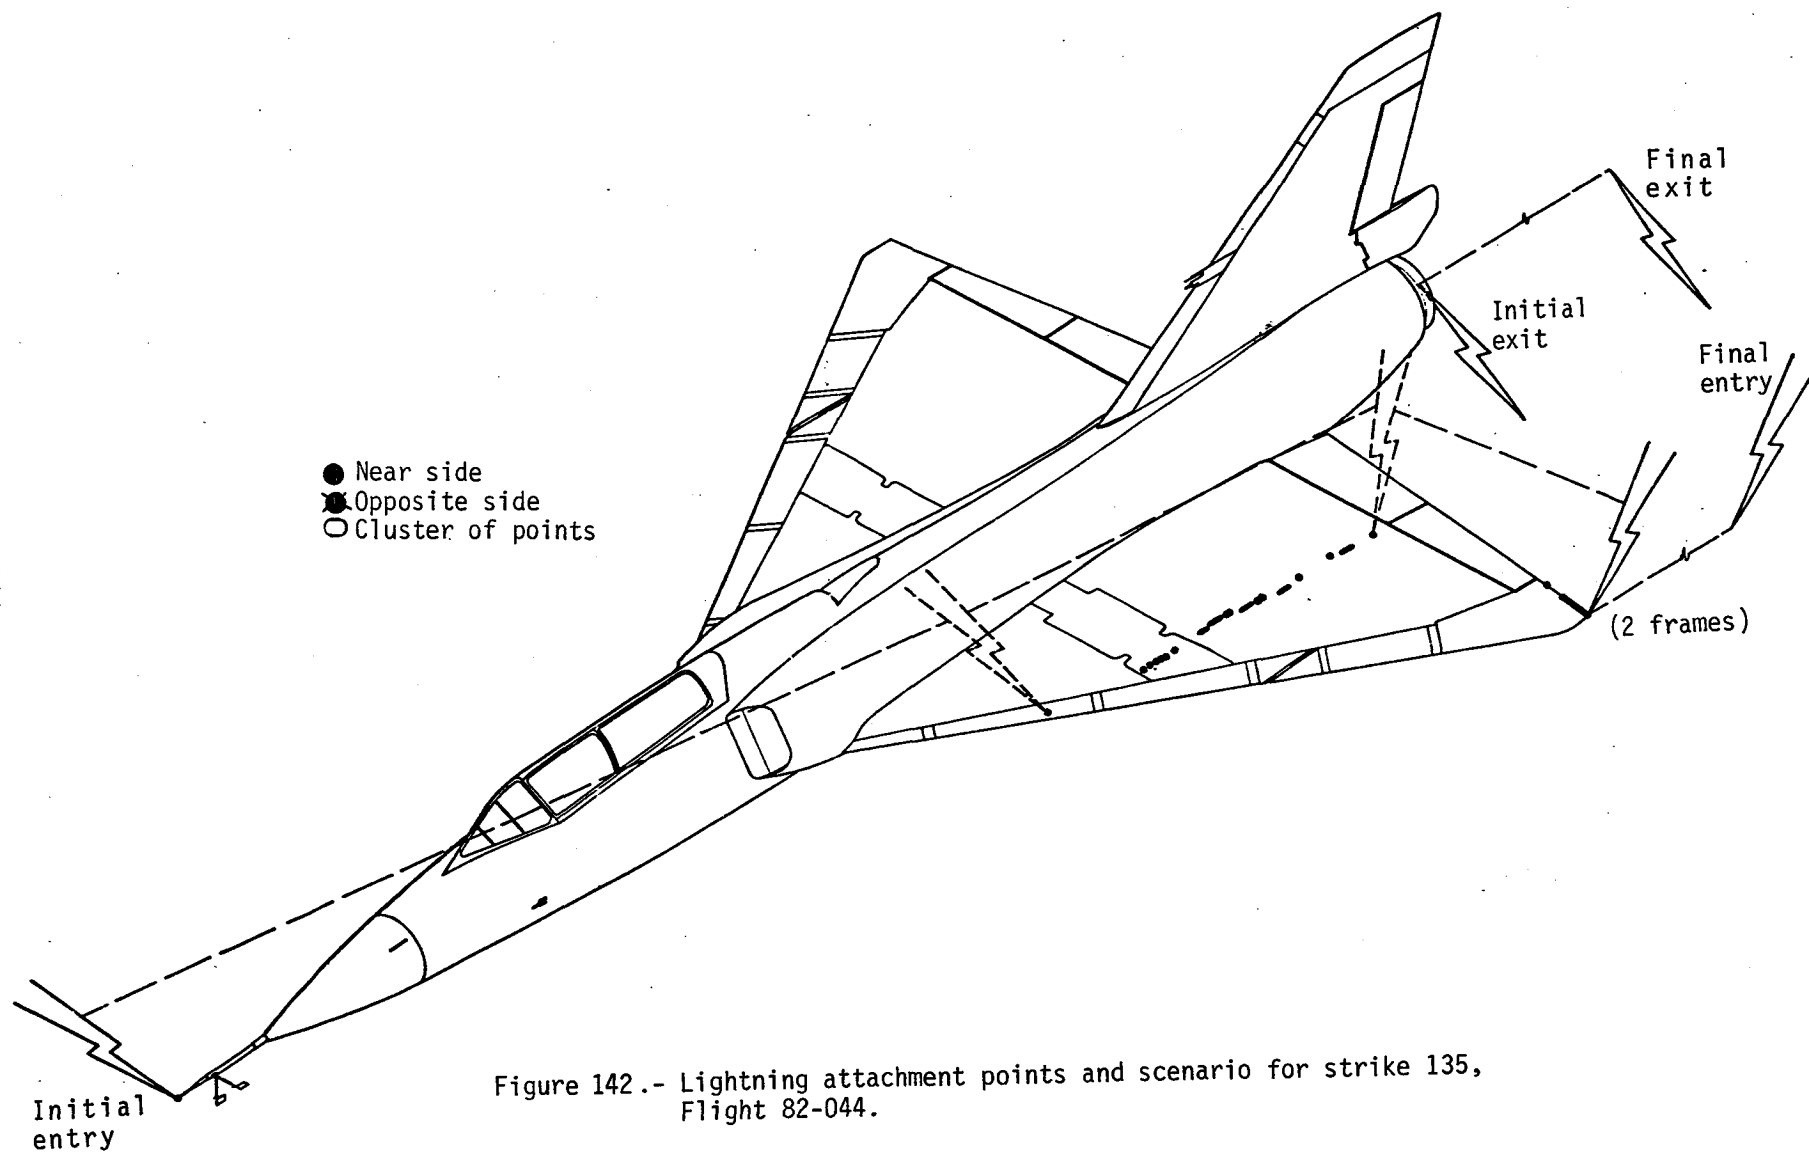
Figure 142.- Lightning attachment points and scenario for strike 135, Flight 82-044.

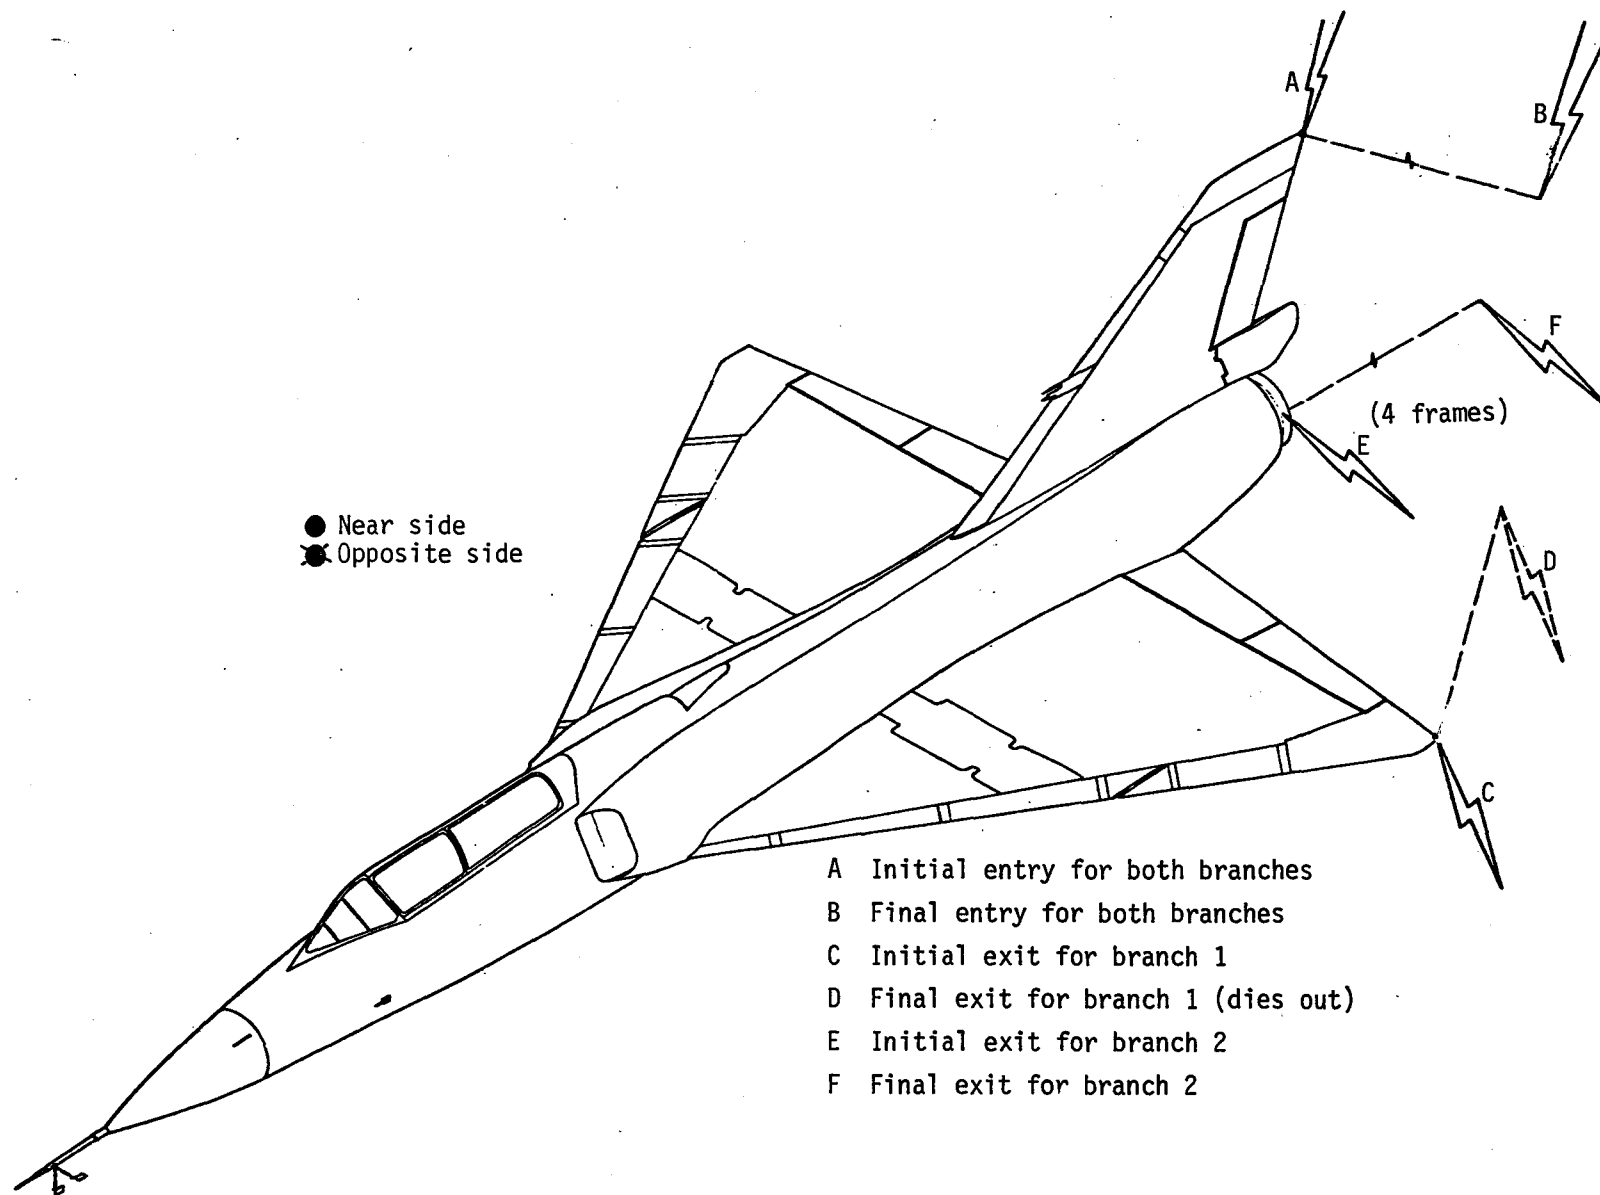
Figure 145.- Lightning attachment points and scenario for strike 136, Flight 82-044.

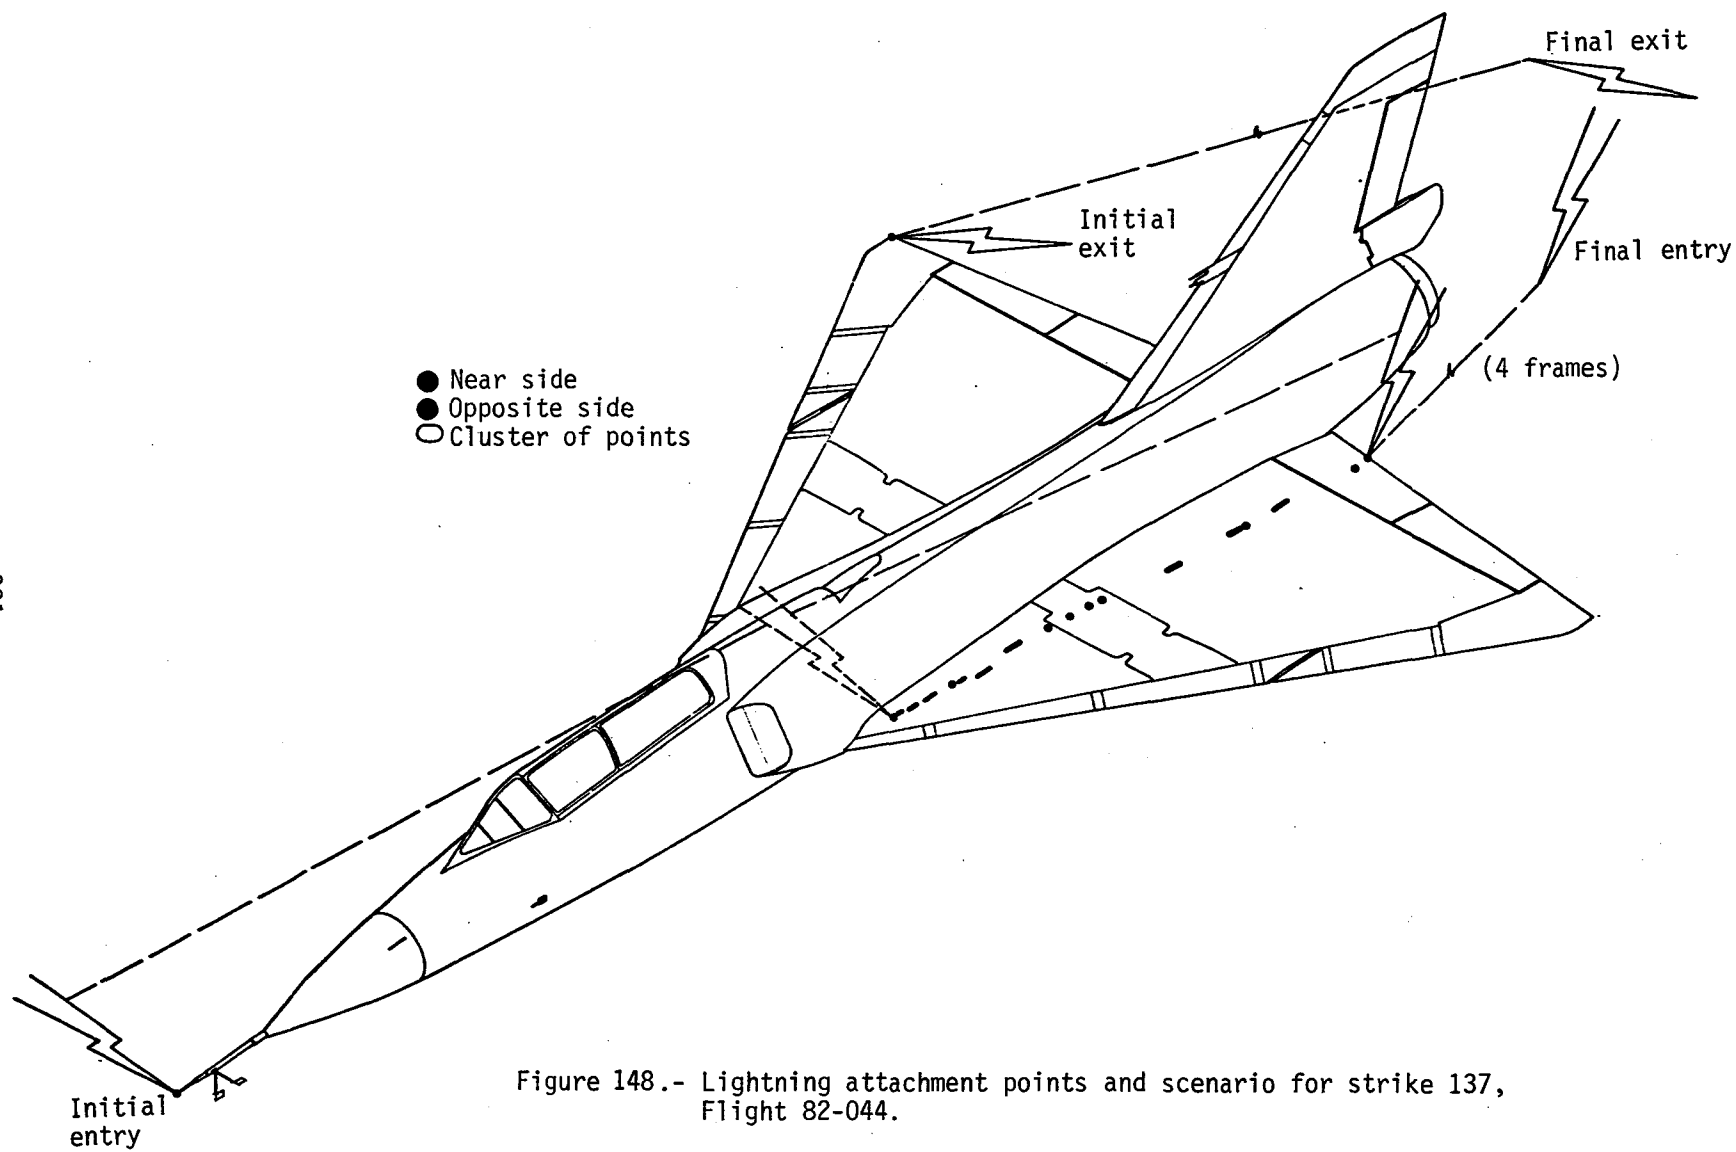
Figure 148.- Lightning attachment points and scenario for strike 137, Flight 82-044.

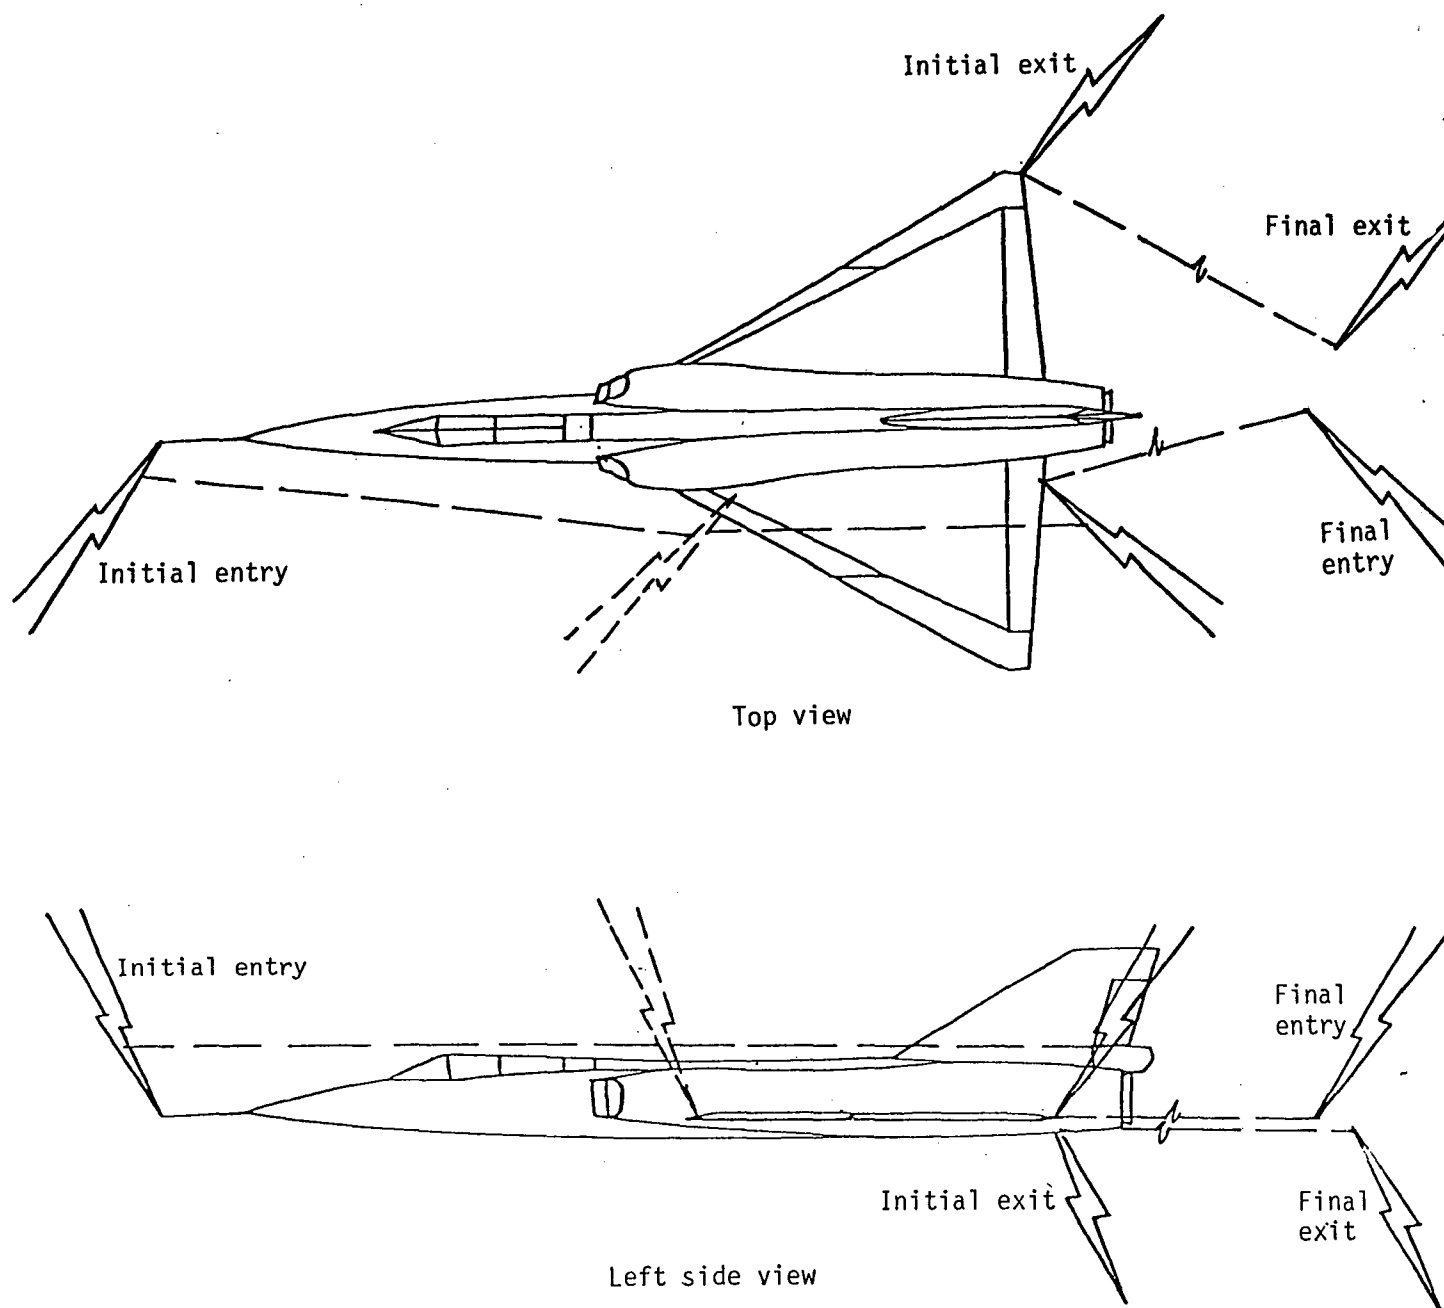
Figure 149.- Lightning attachment point scenario for strike 137, Flight 82-044.
